PROJECT DESCRIPTION: Staff re	quests the designation of prin	nary façades on a contributing	non-residential building.
	<b>-19-026A</b> Drb	ė	
PROJECT LOCATION (S): 40	4 Montezuma Avenue		
PROJECT NAMES:			
OW/AP - State of New Mexico Cultur	al Affairs Department	407 Galisteo St # 260	Santa Fe, NM 87501
PROJECT DATA:			
HISTORIC DISTRICT			<b>,</b>
Don Gaspar Area Downtown :	and Eastside 🗆 Historic	Review 🗆 Transition 🗹	Westside-Guadalupe 🗆
HISTORIC BUILDING STATUS			
Non-Statused   Non-Contributi	ng 🗆 Contributing 🗹	- Significant □ Landma	rk 🗆 N/A 🗆
PRIMARY ELEVATIONS:	North 🗆 S	South D West D East	:
PUBLICLY VISIBLE FACADE-EAS	Γ	Yes ☑ No □	
PUBLICLY VISIBLE FACADE-NOR	TH	Yes ☑ No □	
PUBLICLY VISIBLE FACADE-SOU	ГН	Yes 🗆 No 🗆	
PUBLICLY VISIBLE FACADE-WES	Т	Yes 🖳 No 🗆	
HISTORIC DISTRICT INVENTORY	NUMBER	H27150	
YEAR OF CONSTRUCTION		19305	
PROJECT TYPE			
Status   Primary Elevations	Remodel 🗆 Dem	nolition	ther <u>Rimany</u> Facade

Case # H-19-26A

Address: 404 Montezuma Historic Status: Contributing Historic District: Transition

# HALPIN BUILDING HISTORICAL ANALYSIS AND ASSESSMENT

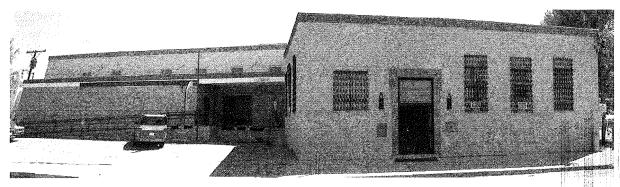
Figure 32, 2017 View of North Elevation with office wing at right. (Note window to left of entry is a different proportion and has an exposed lintel and concrete sill, indicating it is an addition)

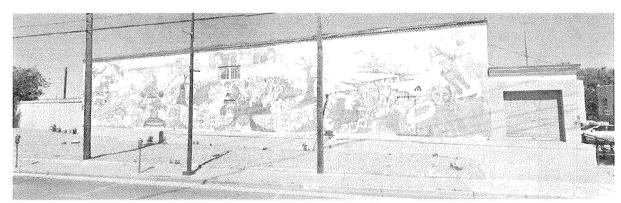
The most significant change to the exterior character of the building was the boarding up of the windows on the east façade and installation of a mural covering the entire Guadalupe Street façade of the warehouse block (Figure 44). According to the 1997 NM Historic Building Inventory Re-survey, the mural was painted by Zara Kriegstein, Gilberto Guzman et al. It was featured in the book "Street Murals" by Volker Barthelmeh in 1982. According to an assessment of the mural that the conservator for the Department of Cultural Affairs undertook in 2015, the book was published within a year or two of the mural's original installation. The panel covering the central double window started to delaminate from the building and fell off the building during an effort to repair it. The remainder of the panel is stored in the basement of the building. Consequently the only window not covered on the east elevation is this central double window. It is reported that as many as four attempts have been made at restoring the mural and its current state differs significantly in both color and form from the original, which is illustrated in the book.

Figure 44. View of east elevation showing mural and enclosed loading dock under canopy at northeast corner

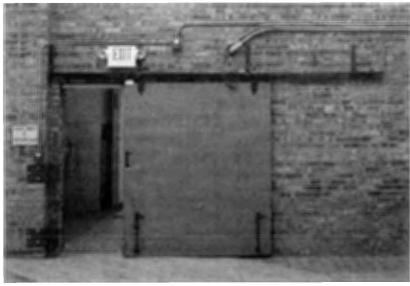
Figure 66. Rolling fire door in basement wall Figure 67. Rolling freight door to south loading wing. Likely original installed in 1970 but possibly relocated

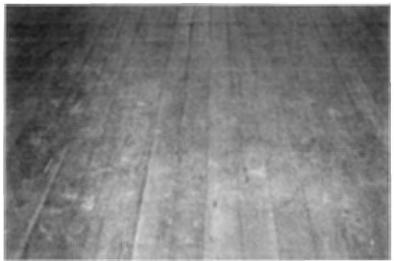
The main warehouse wood floor is in generally worn condition (Figure 76), as would be expected of a softwood floor that is 80-years old. Many boards are splintered and gouged (Figure 75). The thickness of the boards could not be determined during the survey but based on boards that were apparently reused from demolished portions of the warehouse floor for the mezzanine, it appears it may be 2x material. This may allow the floors to be sanded down without affecting the integrity of the tongue and groove construction, although retaining it as the finished floor for the new use may not be practical. While the hardwood overlay in the traffic areas may date to the Ilfeld era, it is unlikely that it is original and would not be practical to retain for the new use. The condition and extent of the original hardwood strip flooring in the office wing is unknown, but the application of what may be to be a poured seamless floor over the top would appear to preclude the ability to restore this floor.

Figure 76. General condition of wood floor at main warehouse is poor

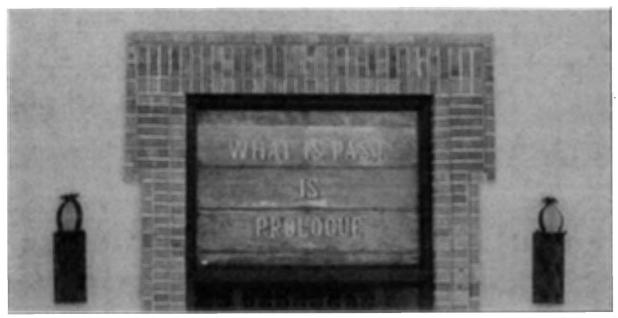
There is no evidence of original signage from the Charles Ilfeld Company but there are two signs from the State Archives era that are mentioned in the 1997 Historic Building Inventory Resurvey: The sign carved into a wood panel over the north street entry to the office wing (Figure 81); and a panted sign on a panel over the north loading dock (Figure 80). The former reads: "What is Past is Prologue"; and the latter reads "A Nation that forgets its past has no future", which is ascribed to Winston Churchill. Saving these signs and relocating them, possibly to the State Archives building, should be considered, if they cannot be incorporated into the new museum.

Figure 81. Sign over entryway to office wing
